TECHNICAL REPORT SL-84-10

HOW TO AVOID DEFICIENCIES IN PORTLAND-CEMENT PLASTER CONSTRUCTION

June 1984

HOW TO AVOID DEFICIENCIES IN PORTLAND-
CEMENT PLASTER CONSTRUCTION

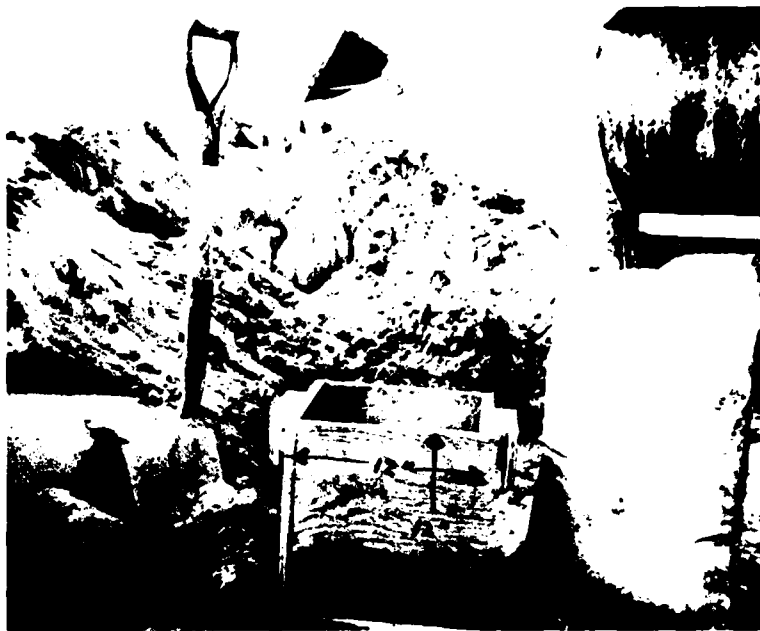
Improper batching
of plaster.

Inspection of mixing site may reveal haphazard procedures that do not conform to specifications.

Lack of quality control at mixer leads to variations in the quality of the plaster.
